Z-9 EH GHF 631 HELICOPTER ACCIDENT INVESTIGATION PRESENTATION

**MINISTRY OF DEFENCE (MOD)
ACCIDENT REPORT, OCTOBER 2025**

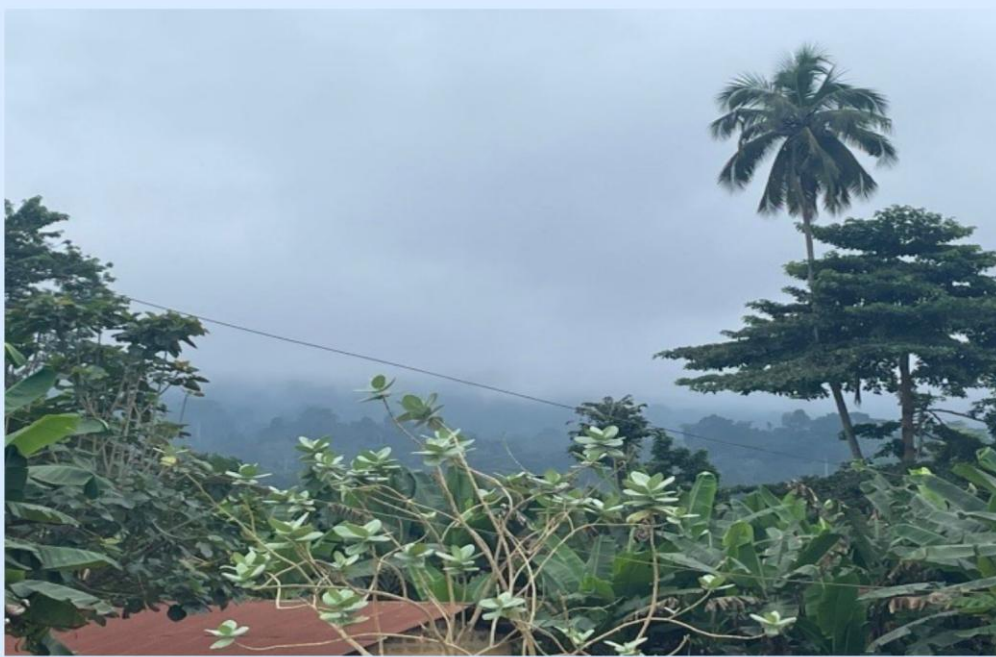
Morning Weather
09:00 hours

- The weather in southern Ghana was poor which delayed departure for about an hour.
- In Accra, conditions were misty with visibility of about 5–7 kilometres and very low clouds starting at only 700–1,100 feet above the ground.
- While the situation improved slightly later in the morning, the early hours were dominated by haze and overcast skies.

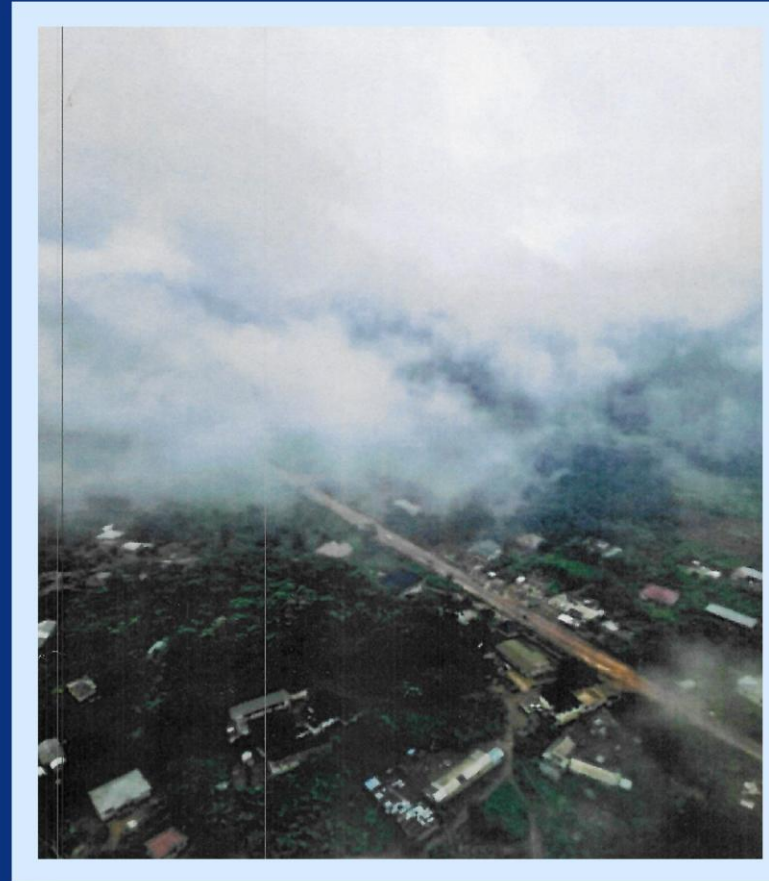
Picture of enroute weather from a passenger on-board the helicopter to a friend before the accident.

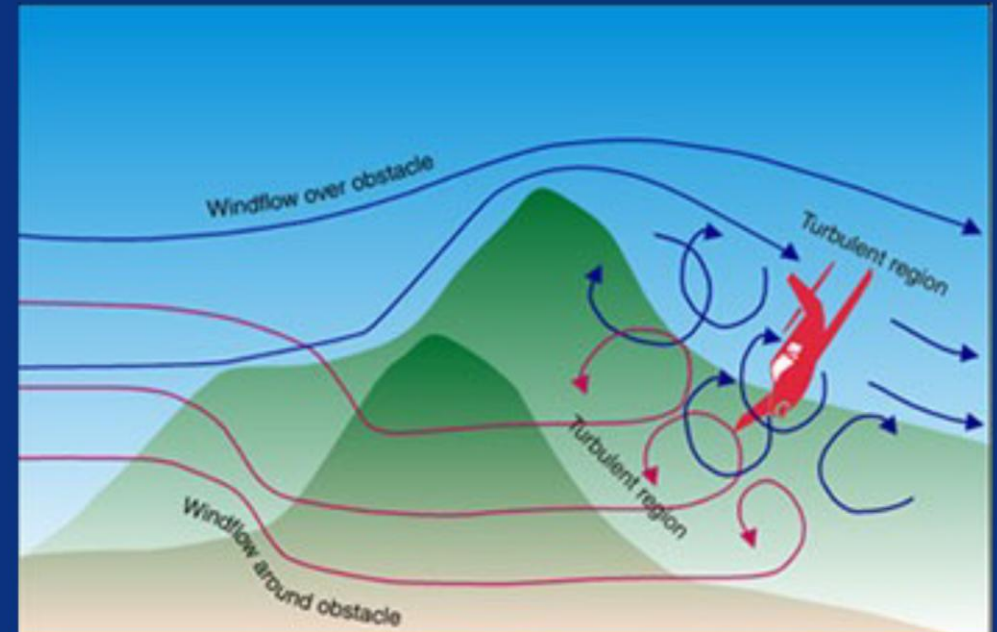
Turbulent wind currents usually occurring around ridge lines, mountains and hills generating sink rates in excess of 1,000 feet per minute in moderate wind conditions.

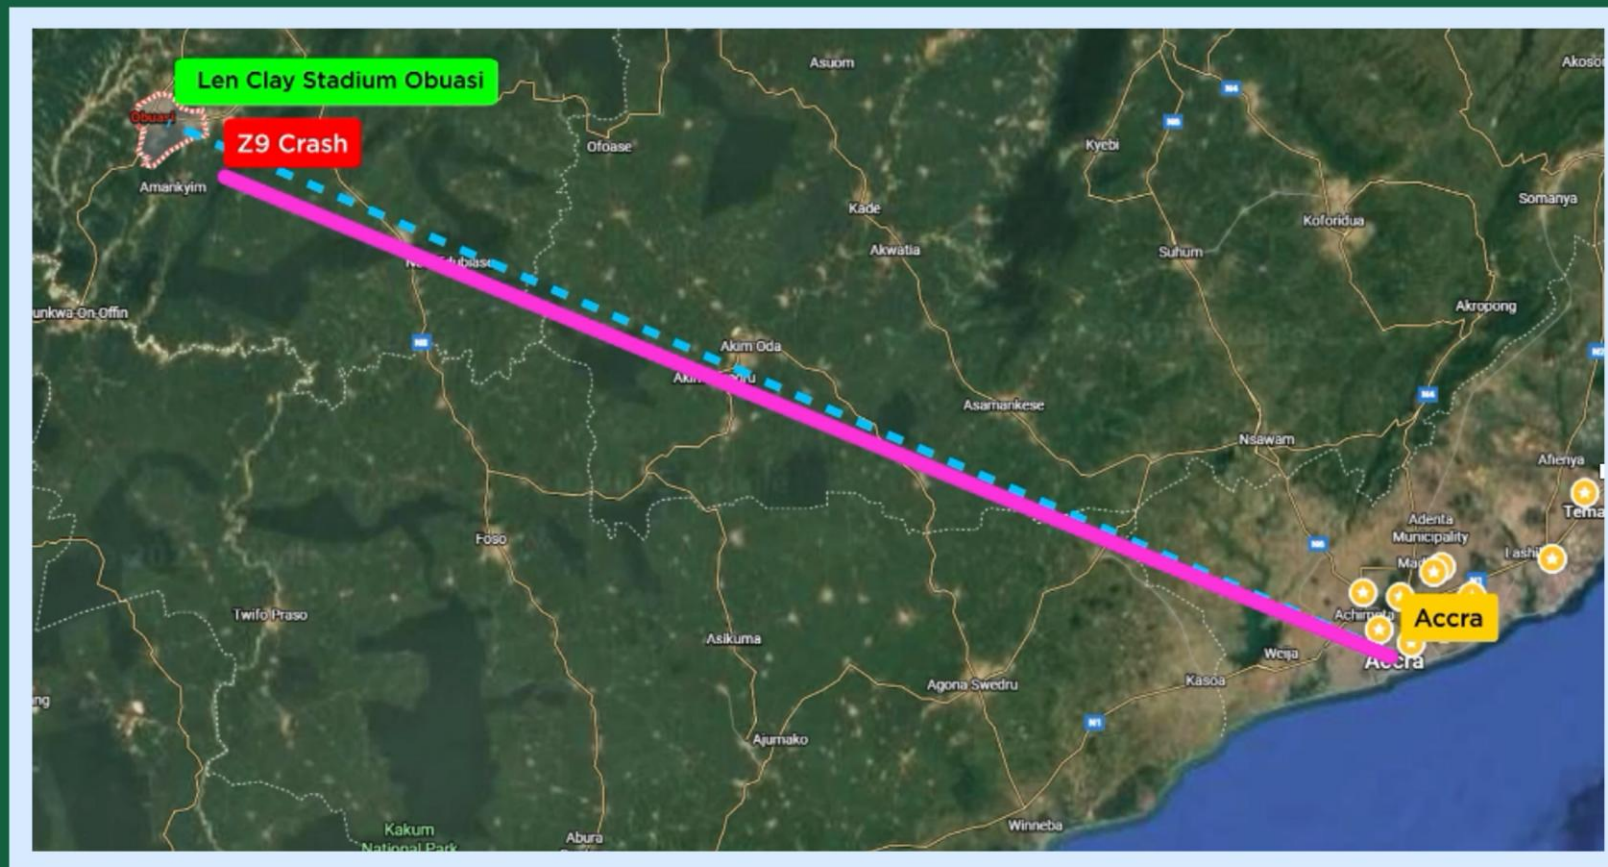
SEQUENCE OF EVENTS

- Suddenly after, the helicopter lost height without change of power or pitch attitude and impacted a ridgeline at 1,370 feet above sea level, about 6.5 miles from destination at 09:58.

The investigation determined that the accident was caused by the sudden loss of altitude and lift due to downdraft.

This loss of altitude without change in power or pitch attitude is consistent with downdraft associated with changing environmental conditions over high terrain.
